NEW LA BELLE LAKE DAM
LEWIS COUNTY, MISSOURI
MO 10372

PHASE I INSPECTION REPORT NATIONAL DAM SAFETY PROGRAM

Name of Dam: New Labelle Lake Dam, Missouri Inv. No. 10372
State Located: Missouri
County Located: Lewis
Stream: Unnamed Tributary of Troublesome Creek
Date of Inspection: September 27 and October 6, 1978

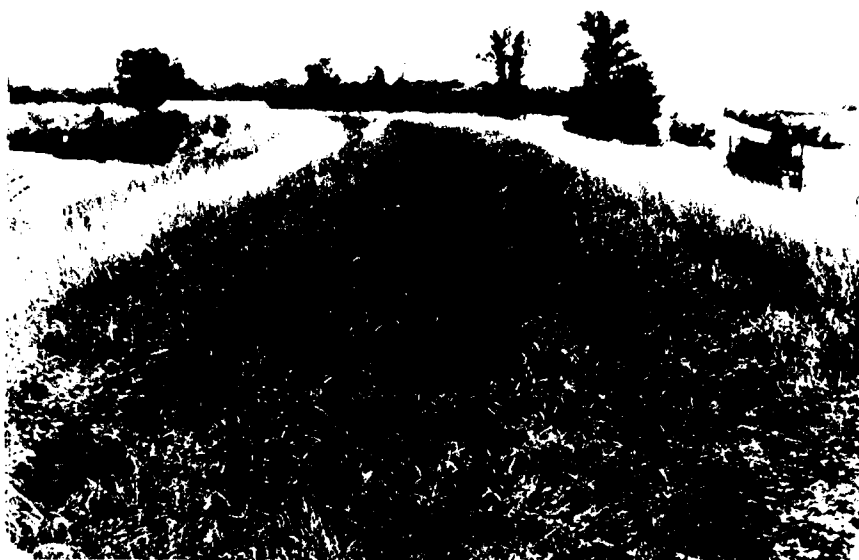
Photo 1 - View along crest of dam taken at right abutment.

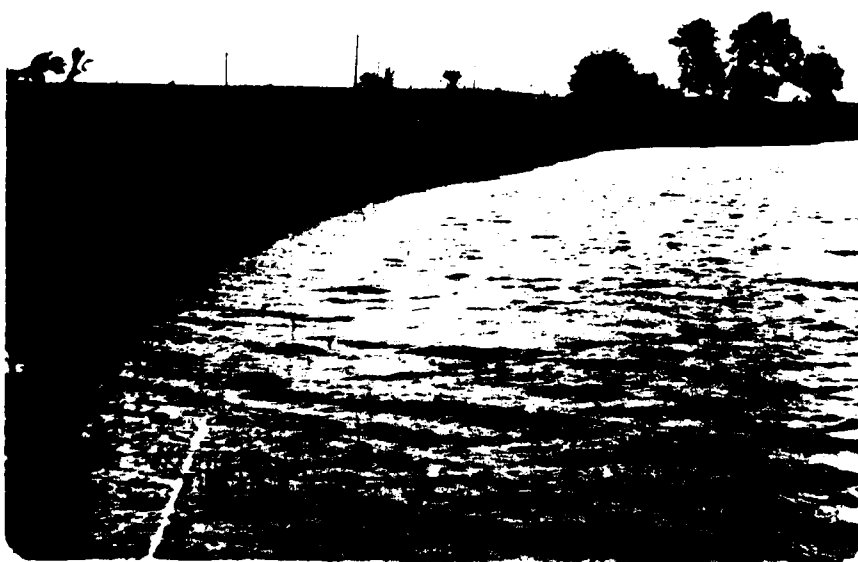
The upstream embankment slope did not exhibit significant sloughing of the embankment material. The riprap, which was placed originally to elevation 691.0, is only 1 foot above the maximum water surface elevation following the reconstruction of the drop inlet structure. However, the heavy grass on the upstream slope is adequately protecting the embankment. Some small trees were observed growing on the upstream embankment slope during the inspection.

Photo 4 - Picture of upstream slope to right of drop inlet spillway taken at crest near spillway.

The dam is maintained by the Labelle Water Superintendent. Maintenance for the dam appears to be adequate. The small trees beginning to grow on the upstream slope should be cut before they become a hazard.

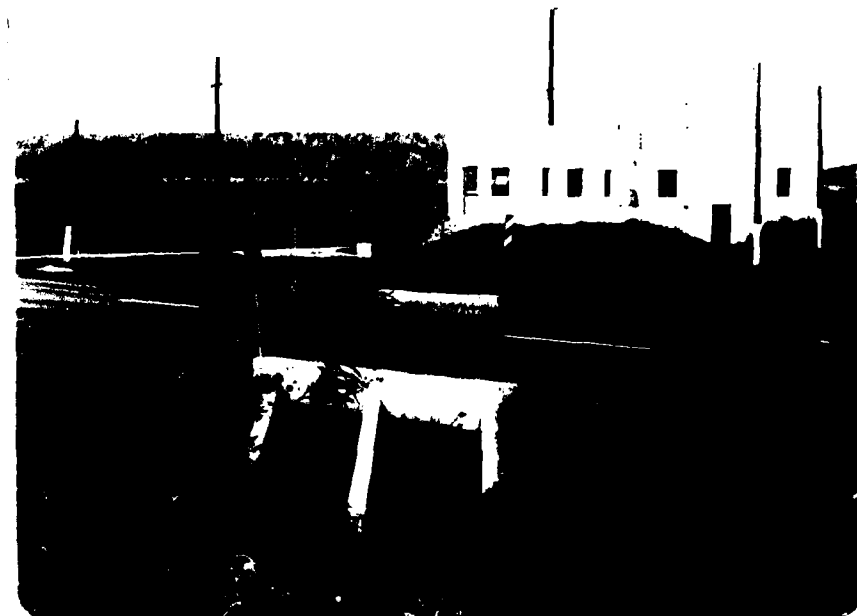
Photo 6 - Picture of water supply pumping house. Note downstream slope of dam in background.

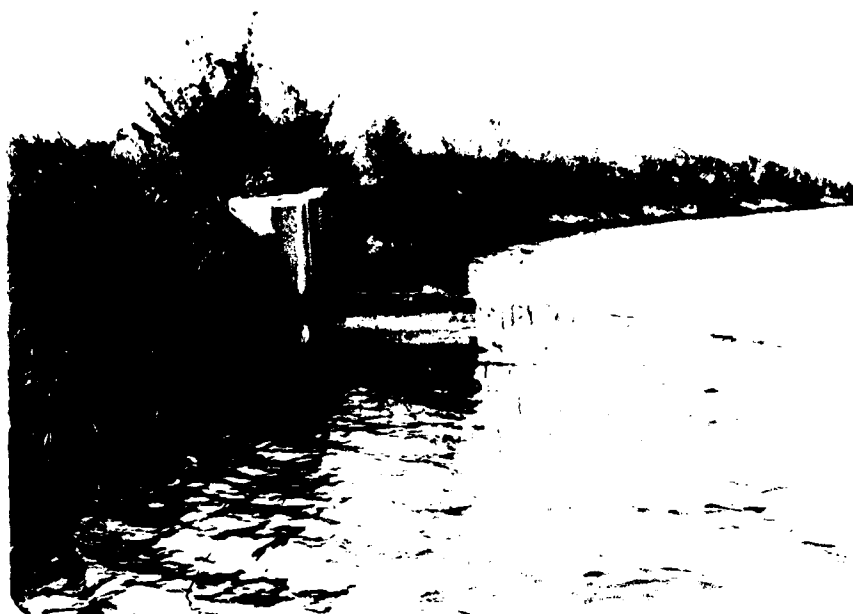
Photo 7 - Picture of drop inlet for service spillway along with hoist arrangement for water supply piping.

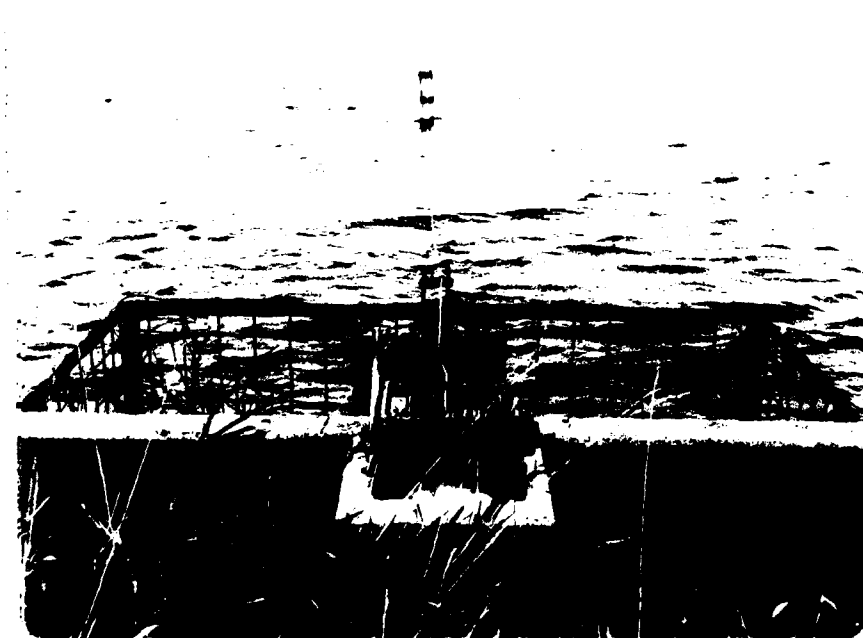
Photo 8 - Picture of hoist arrangement for water supply piping.

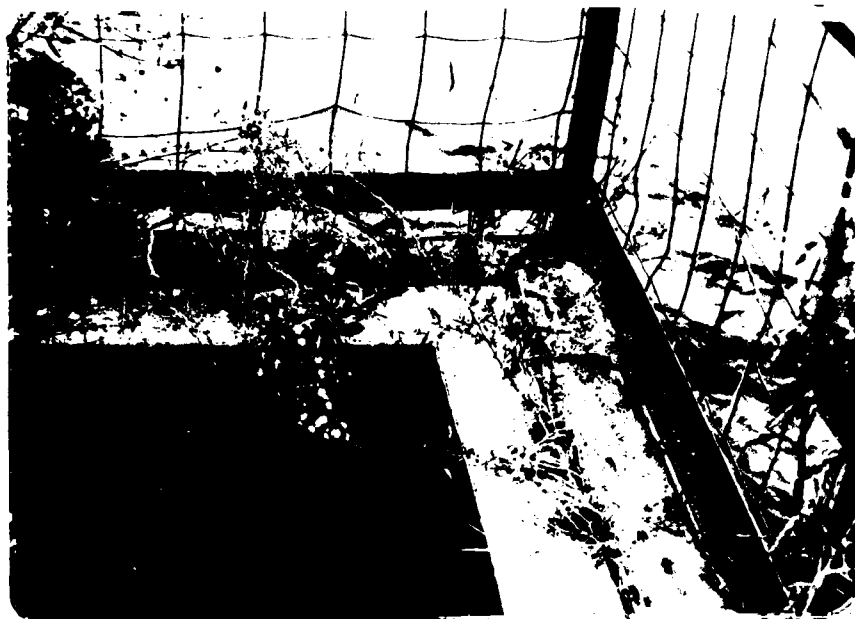
The concrete drop inlet structure is in a deteriorated condition. Several major vertical cracks, minor erosion and moderate spalling on the concrete were observed.

Photo 9 - Close-up of inlet structure for service spillway.
Note cracked concrete on outside concrete wall.

The service spillway drop inlet structure should be repaired to prevent continuous flow through the pipe. This condition is especially critical due to the likely leakage in the C.M.P. pipe and the poor condition of the service spillway discharge channel.
